CITY OF FAIRFAX, VIRGINIA

TAX MAP NO.
 #58-1-02-021

APPLICANT
 EYA DEVELOPMENT LLC
 4800 HAMPTON LANE SUITE 300
 BETHESDA, MD
 ATTN: WYNDHAM ROBERTSON
 301(634-8649)

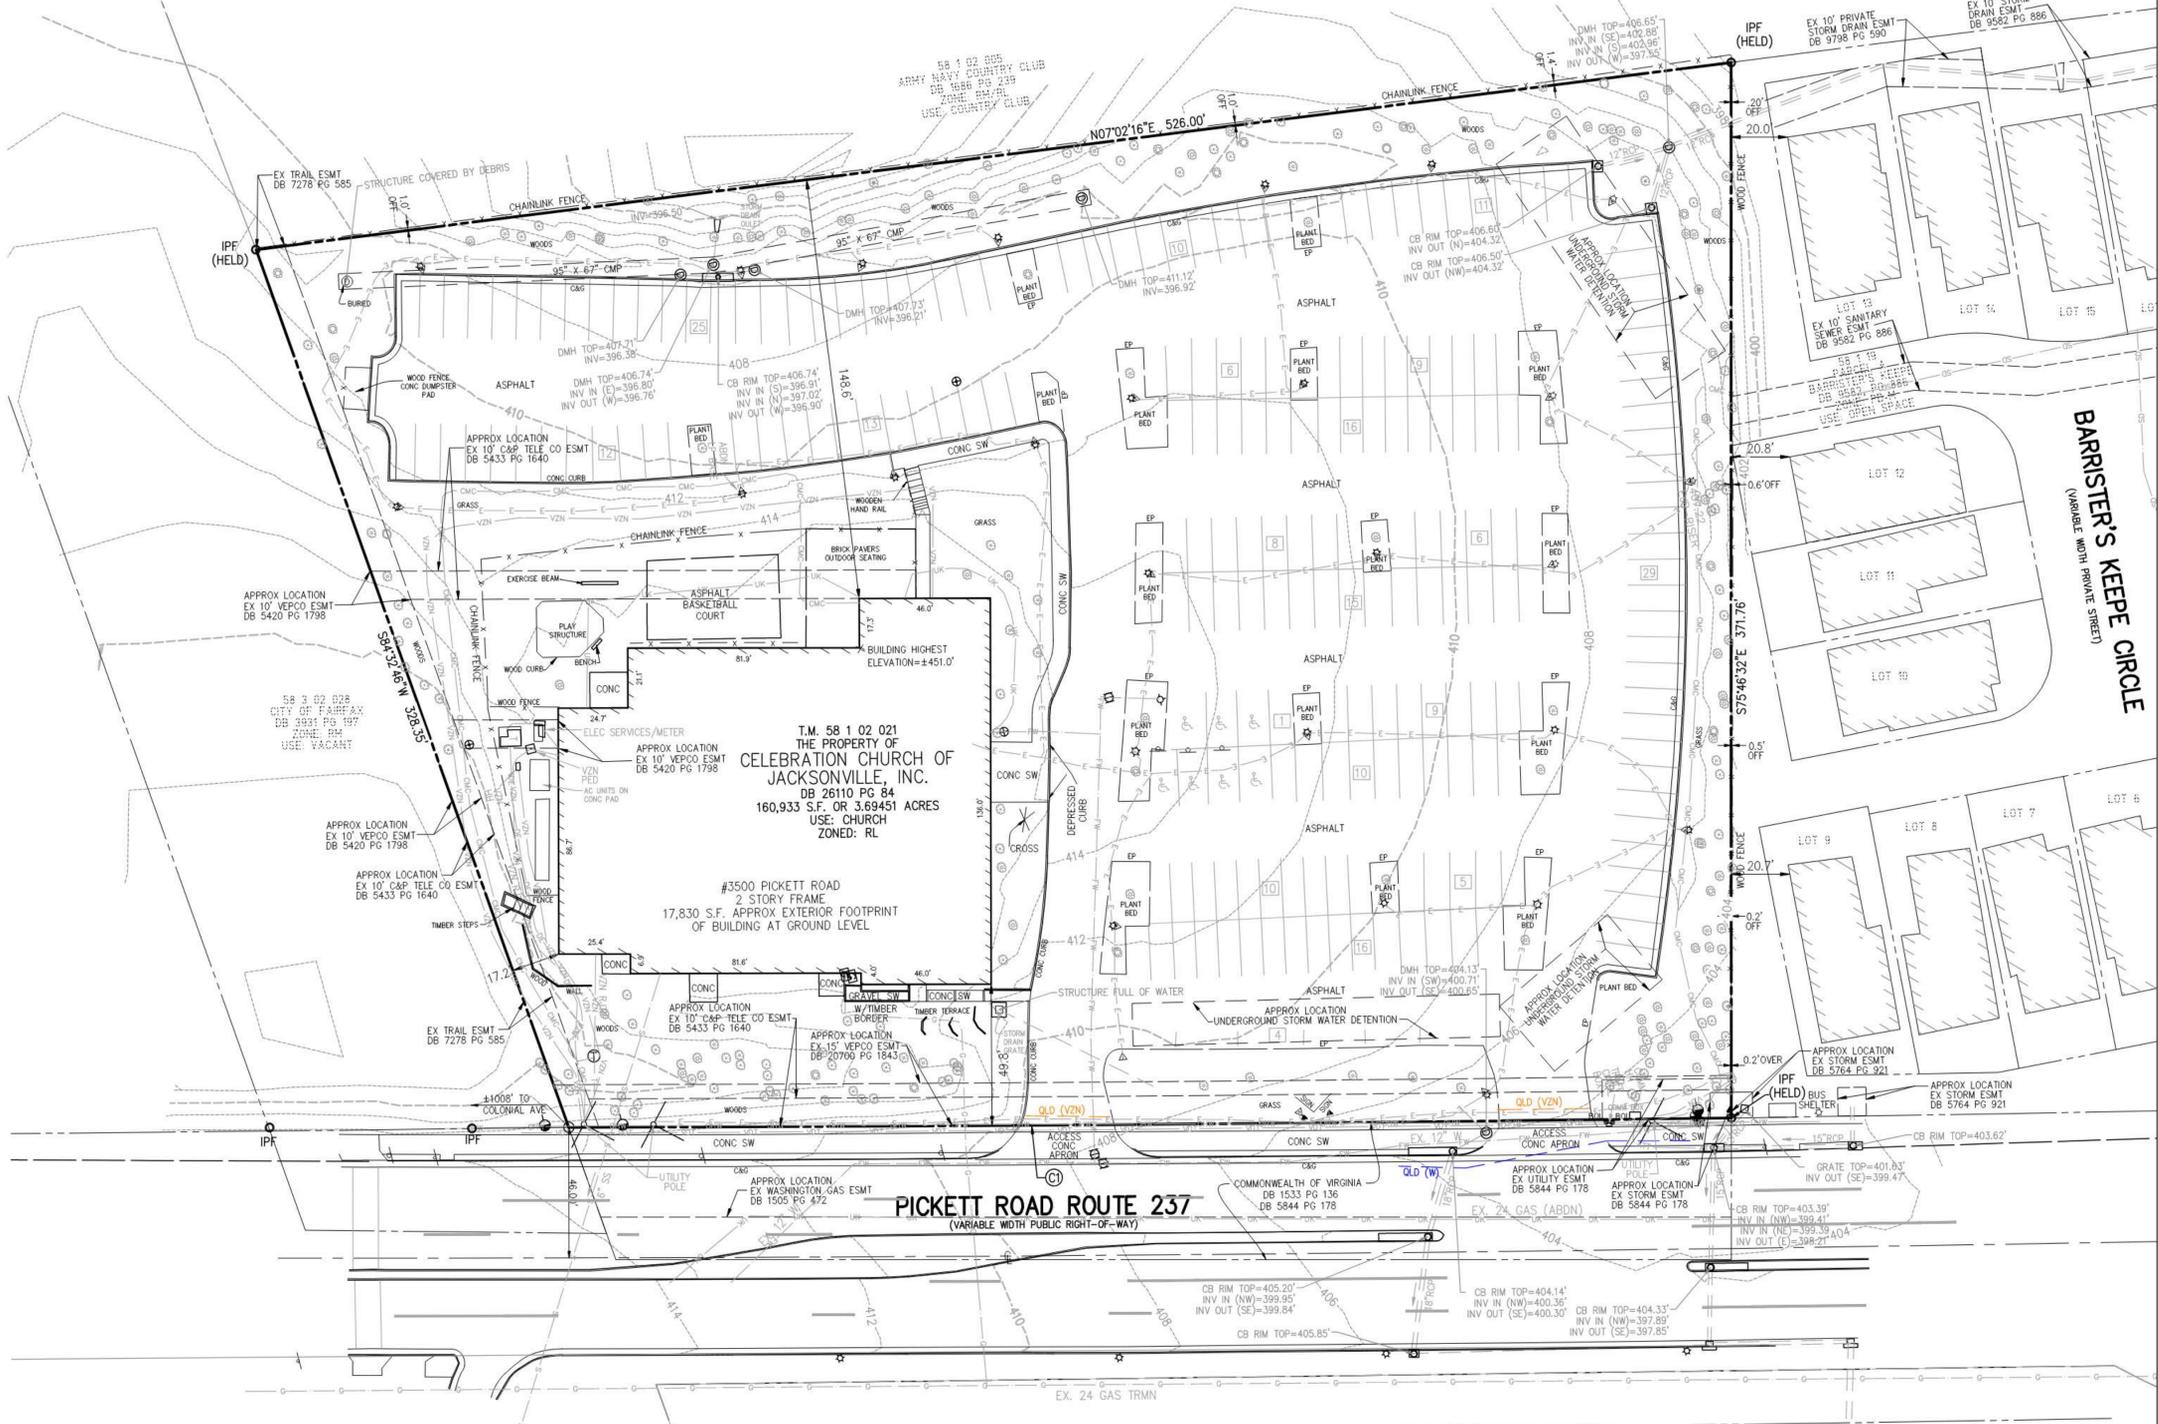
EXISTING CONDITIONS PLAN

BEGINNING FOR THE SAME AT AN IRON PIPE FOUND (HELD) LYING ON THE WESTERLY RIGHT-OF-WAY LINE OF PICKETT ROAD, ROUTE 237 (VARIABLE WIDTH PUBLIC RIGHT-OF-WAY), SAID IRON PIPE FOUND (HELD) MARKING THE SOUTHEASTERLY CORNER OF PARCEL A, BARRISTER'S KEEPE AS RECORDED IN DEED BOOK 9582 AT PAGE 886 AMONG THE LAND RECORDS OF FAIRFAX COUNTY, VIRGINIA THENCE; RUNNING WITH THE WESTERLY RIGHT-OF-WAY LINE OF SAID PICKETT ROAD:

- SOUTH 84°32'46" WEST, 328.35 FEET TO AN IRON PIPE FOUND (HELD) MARKING A SOUTHEASTERLY CORNER OF THE PROPERTY OF ARMY NAVY COUNTRY CLUB AS RECORDED IN DEED BOOK 1686 AT PAGE 239 AMONG AFORESAID LAND RECORDS; THENCE LEAVING THE AFORESAID PROPERTY OF CITY OF FAIRFAX (DB 3931 PG 197) AND RUNNING WITH THE SAID PROPERTY OF ARMY NAVY COUNTRY CLUB

- NORTH 07°02'16" EAST, 526.00 FEET TO AN IRON PIPE FOUND (HELD) MARKING THE SOUTHWESTERLY CORNER OF THE AFORESAID PARCEL A, BARRISTER'S KEEPE (DB 9582 PG 886); THENCE LEAVING THE AFORESAID PROPERTY OF ARMY NAVY COUNTRY CLUB (DB 1686 PG 239) AND RUNNING WITH SAID PARCEL A

- SOUTH 75°46'32" EAST, 371.76 FEET TO THE POINT OF BEGINNING CONTAINING 160,933 SQUARE FEET OR 3.69451 ACRES OF LAND, MORE OR LESS.
